Volare' Carburetors, LLC

Service Bulletin: SB-11 Rev A

SUBJECT – UNAPPROVED REPAIR PRACTICE

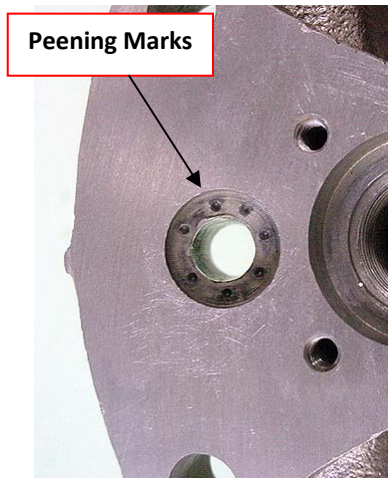
Fact: Peening the area around the bearing bore causes the mixture shaft loads to bear on small, upset metal projections which will wear away quickly. Thus, the repair will be short lived. Additionally, an airtight seal between the mixture control shaft and the throttle body is imperative. If the seal is compromised and outside (ambient) air enters the float bowl, an excessively rich fuel/air mixture will occur. The rough surface can prevent the necessary airtight seal.

Examples of unauthorized peening of the mixture shaft bore are shown in Figures 1 & 2 on page 2, (Fig. 1 bottom view, Fig. 2 top view). Figure 3 shows a properly repaired mixture shaft bore. The factory can make such repairs. If the mixture shaft bearing bore has inadequate metal remaining, contact Volare' to have the bore properly repaired.

Figure 1: **Peened Example**

4. **Compliance:** At the next carburetor disassembly or sooner if an excessively rich mixture is experienced:
 - a. Examine the mixture shaft bearing bore and area around it. If unauthorized repairs have been accomplished, the mixture shaft bearing bore is oversized, or the sealing surfaces are damaged, send the carburetor to Volare for repair.

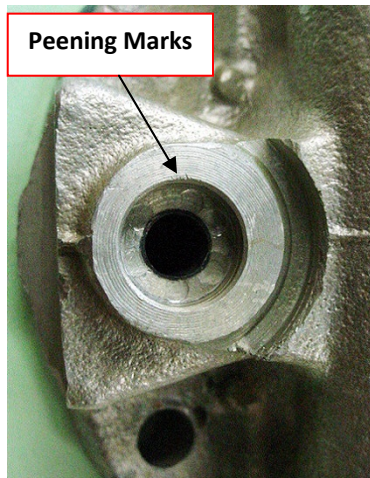
Figure 2: **Peened Example**

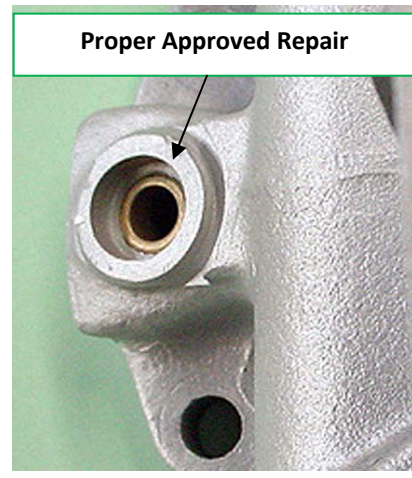
Figure 3: **Proper Bushed Repair**
