SERVICE BULLETIN

Feb. 1979

#A1-79

SUBJECT: HA-6 Aircraft Carburetor Part No. A10-5206-1

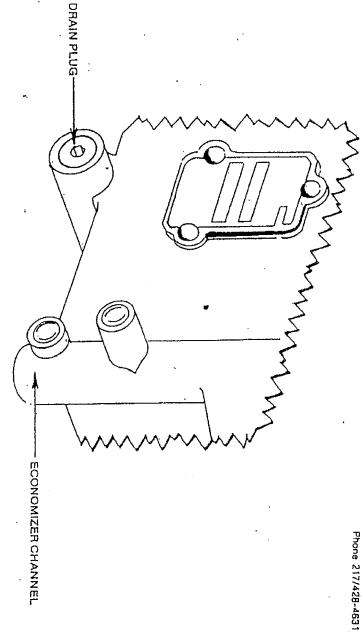
SPECIAL KIT #665-821

To improve the sealing of the internal economizer channel, remove the economizer channel plug #80-150 and replace it with #80-364 brass plug.

INSTALL WITH RUBBER SIDE TOWARD CARBURETOR COAT CHAMFER AND-TWO THREADS WITH LOCTITE DURING ASSEMBLY 80-364 NEW BRASS ECONOMIZER PLUG REPLACES 80-150 16-A56 WASHER -- 80-150 PLUG 298-1 SEAL + 66-12 SAFETY WIRE
