Marvel-Schebler/Tillotson

SERVICE BULLETIN

#A2-78

SUBJECT: IMPROVED METHOD OF SEALING PUMP AND ECONOMIZER RODS TO REDUCE THROTTLE FRICTION ON MODEL HA SERIES CARBURETORS.

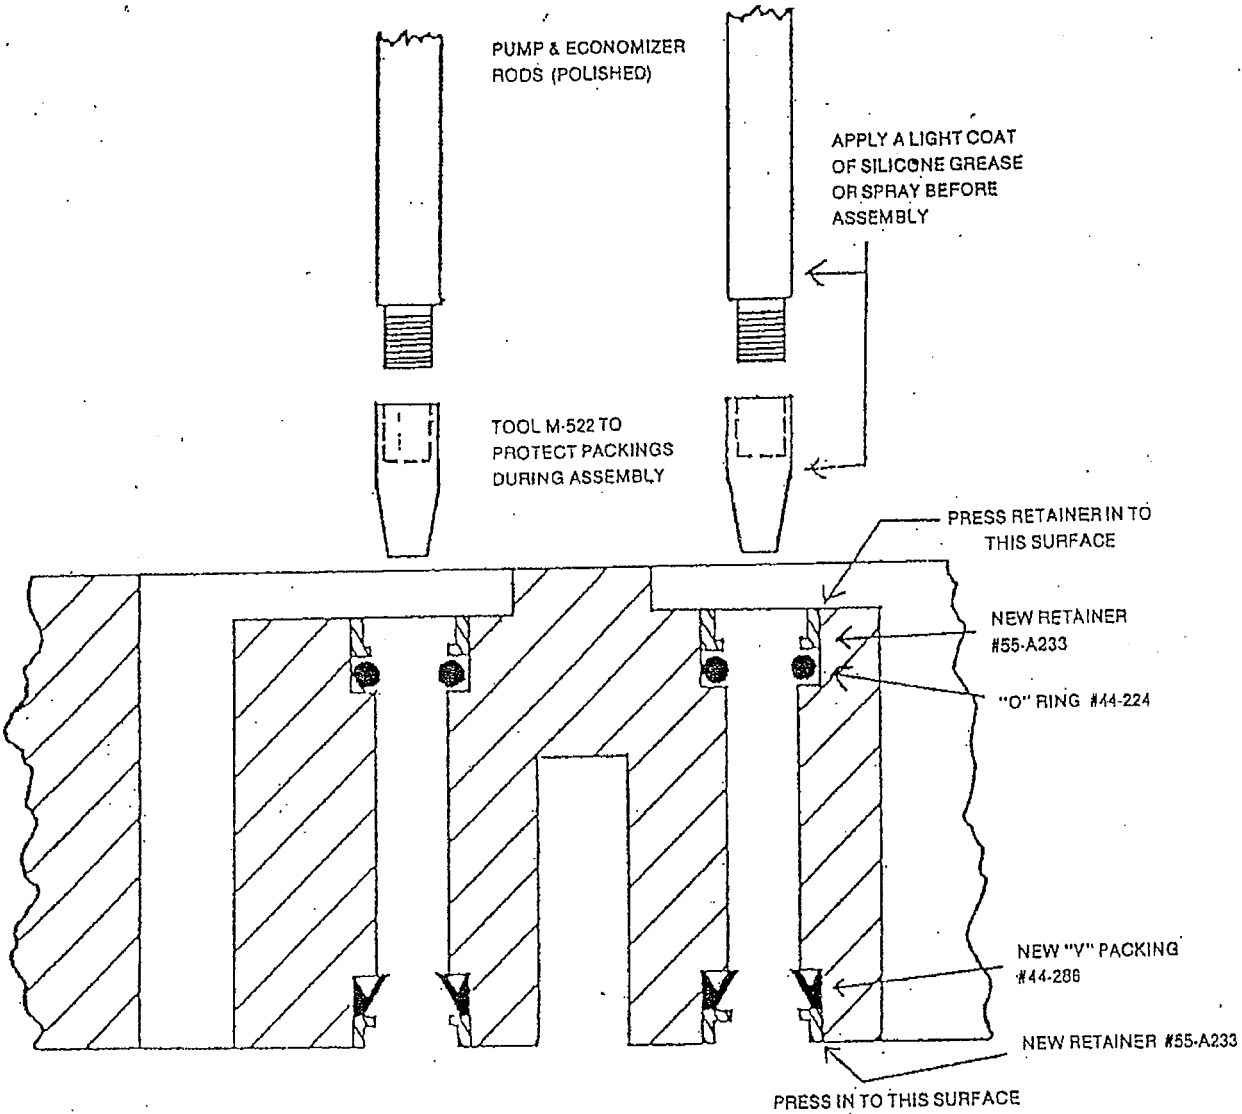
Some applications of Model HA carburetors have been reported to have a tight "throttle" condition where considerable force is required to open and close the throttle.

We have reduced the force to move the throttle by changing the sealing design of the accelerator pump and economizer rods and an improved finish on the rods using an electro-chemical polishing procedure.

Kits contain the new polished rods, new "v" packings, "O" rings and retainers and an installation tool to protect packings during assembly.

Assemble in accordance with the following drawing. Use manual procedure to complete carburetor assembly.
