## Marvel-Schebler Aircraft Carburetors LLC

## Service Bulletin: SB-10 Rev B

## SUBJECT – UNAUTHORIZED THREAD SEALANT

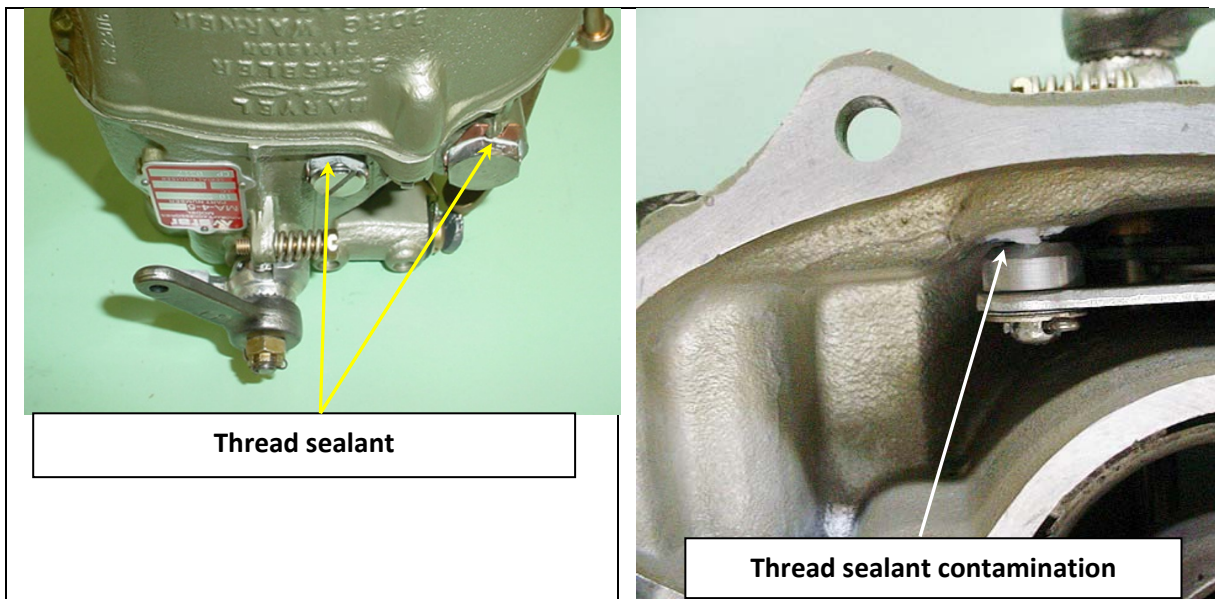
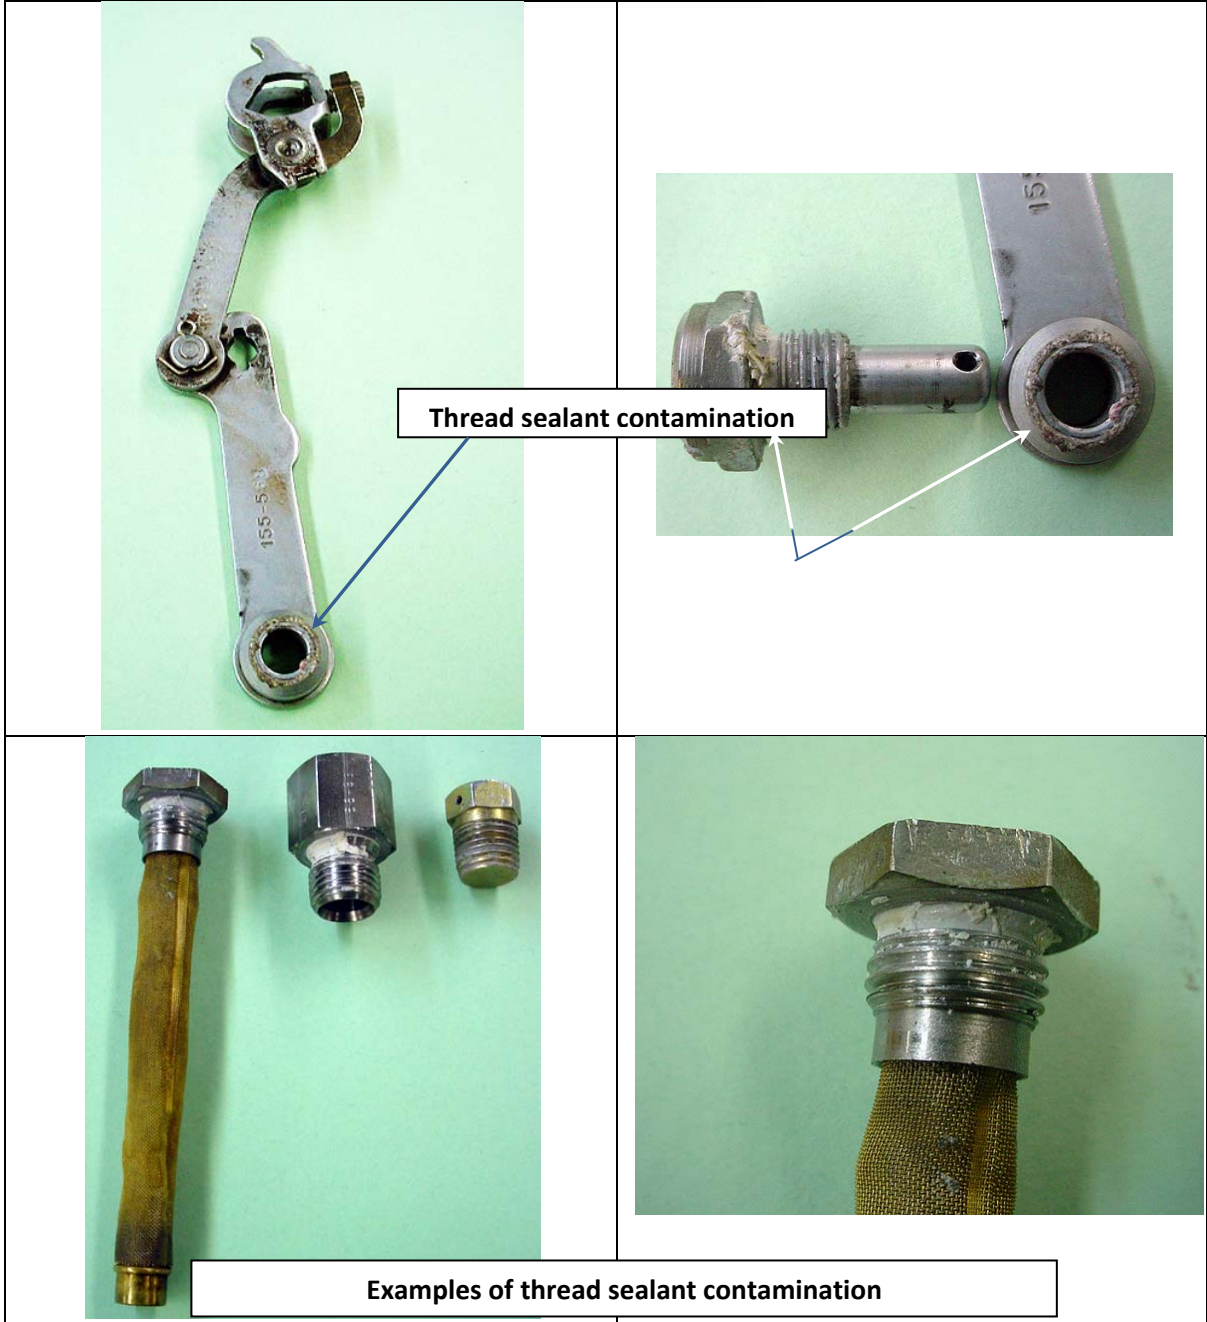
- Immediately inspect such carburetors for evidence of thread sealant around, but not limited to, various fittings particularly the inlet fittings, bowl drain plugs and, on MA-4-5™, MA-5™, and MA-6™ series carburetors, the accelerator pump pivot screw. Thread sealant can often be seen as a whitish appearing hard or semi-hard paste extruding from under a fitting (see photos) but removal of the fittings may be required to conclusively exclude the presence of unauthorized sealant.

- If thread sealant is present, immediately remove the carburetor from service, disassemble it, remove the thread sealant, and inspect all passageways, jets, mechanisms, screens, etc., for contamination by the sealant. Using the appropriate Marvel-Schebler® service manual and all applicable Service Bulletins for the carburetor model being repaired, confirm that all techniques and materials for repairs to be accomplished are Marvel-Schebler® approved. Clean, inspect, and reassemble the carburetor in accordance with the appropriate Marvel-Schebler® service manual. Marvel-Schebler® Service Bulletins can be accessed at [Tempestplus.com](http://Tempestplus.com).
