**Marvel-Schebler® Aircraft
Carburetors, LLC**

Service Bulletin: SB-17

Original Date: August 12th, 2010

SUBJECT – BODY TO BOWL FUEL LEAKS

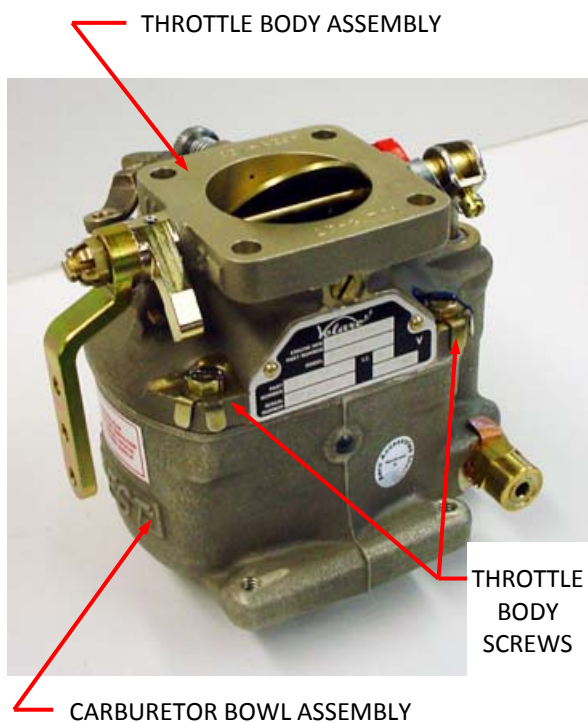
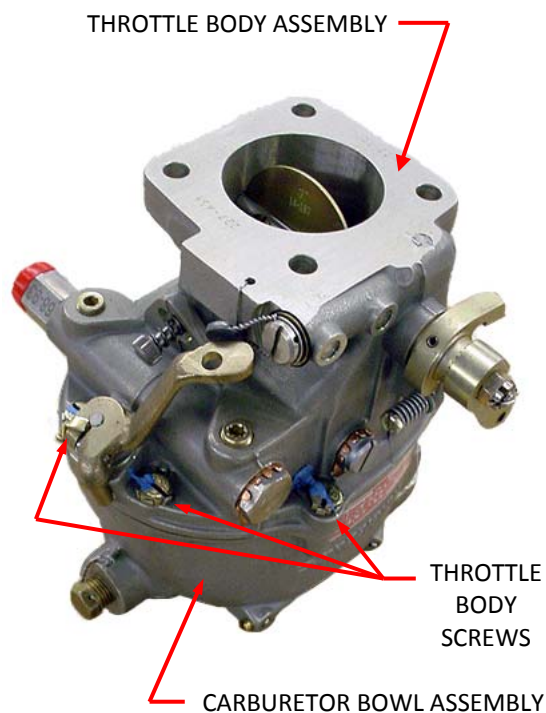
- Models MA-3™, MA-3A™, MA-3PA™, MA-3SPA™, MA-4™, and MA-4SPA™ have four (4) screws.
- Models MA-4-5™, MA-5™, MA-4-5AA™, MA-6™, and MA-6AA™ have six (6) screws.
