Volare Carburetors, LLC

Service Bulletin: SB-3 Rev A

Revision Date: June 8th, 2010

SUBJECT – HA-6™ ACCELERATOR PUMP PLUNGER.

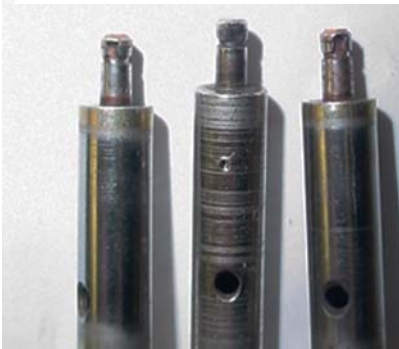
- 2. Reason:** Reports of accelerator pump plunger retaining clips separating from pump stems have been received. This condition renders the accelerator pump inoperative and may result in limited throttle movement.

- 3. Background:** The attached photos show pump stems having severe wear above the retaining clip grooves (Figs 1 & 2). Normal stems (Figs 4 & 5) are shown for reference. Volare is not aware of instances of such advanced wear in stems manufactured by Volare. The rough surface-finish (center, Fig. 1) and worn clip grooves (outer stems, Fig. 3), are not similar to design specifications for stems manufactured by Volare.

Note: Rough Surface finish

Figure 1
Three bad Accelerator Pump Stems.

- b. Within 25 hours of operation after the date of this FLIGHT SAFETY Service Bulletin or prior to March 15, 2009, whichever comes first, remove the bowl cover and inspect the accelerator pump stem. No discernable wear in the clip groove is permitted. Replace any stem exhibiting a rough surface finish, a non-standard groove/head configuration and/or wear in the clip groove, however slight, with a NEW plunger assembly (part number is carburetor model dependent), a NEW pump rod guide, part number 88-92 and a NEW clip, part number 78-A295 supplied by Volare on or after March 4, 2008.

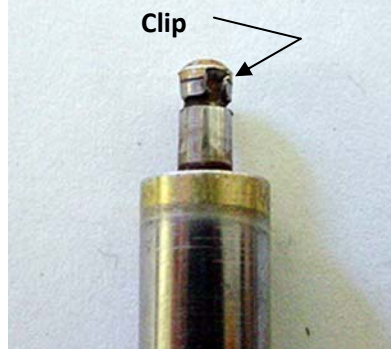
Note: Wear from Retaining Clip

Figure 2
Close up showing wear from Retaining Clip.

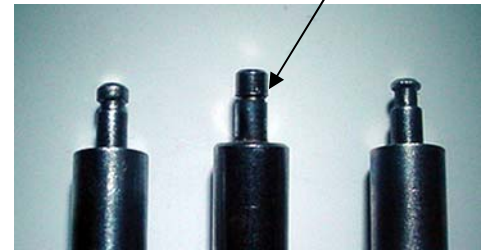
Center Stem is Good

Figure 3
Machining differences among different stems

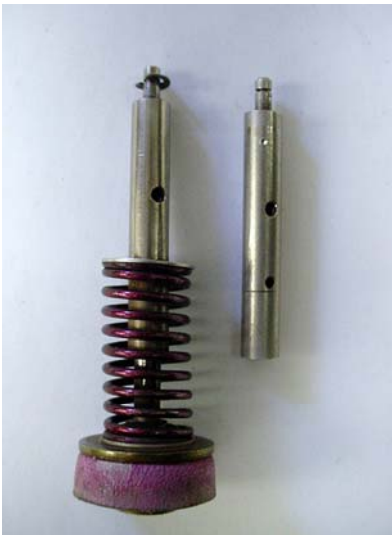
Figure 4
Two good accelerator pump stems, one with clip still installed.

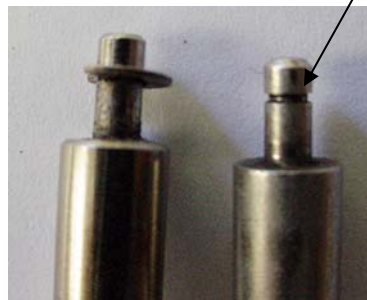
Note: Retaining Clip groove is pristine

Figure 5
Close up detailing lack of wear on good stems.

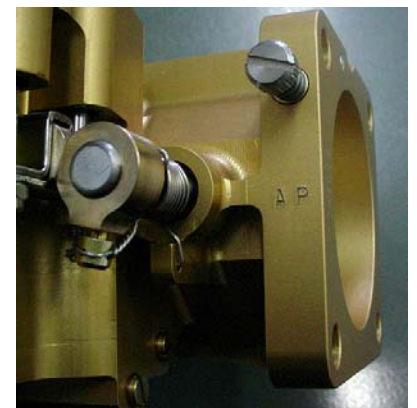
Figure 6
Stamp Flange with 'AP' in location shown after compliance with this service bulletin SB-3.

7. **Identification/Marking:** Upon completion of this Flight Safety Service Bulletin, stamp the letters “AP” in letters 1/8-inch tall (nominal) on the side of the carburetor flange below the idle mixture needle approximately midway between the upper and lower bolt holes (Fig 6).
