**Volare Carburetors, LLC**

**Service Bulletin SB-4 Rev. B**

**SUBJECT: BOWL CLEARANCE MA- SERIES CARBURETORS**

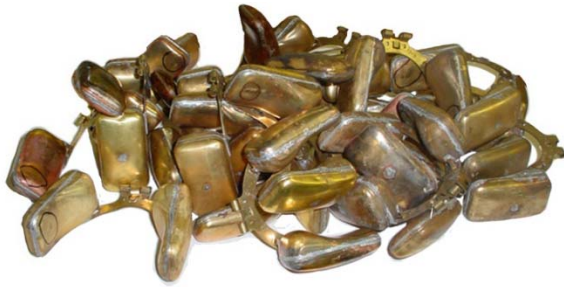
**Fig. 1**

1. **Reasons:** **Warning:** **Failure to follow this advice may result in engine malfunction, damage, injury or death.** Reports of sticking, leaking and/or worn floats have been received, see Figure 1. The specified float/bowl clearance **MUST** exist to ensure proper operation.

**Floats with Rubbing Wear – FEB 2009**

With the clearance tool M-510 used with the (MA-3, MA-4 series) or M-509 used with the (MA-5, MA-6, MA-4-5 Series) in place, orient the carburetor body with one pontoon uppermost, see Figure 2. Check the clearance between the float pontoon and the bowl wall. A .081 inch gage pin (models MA-2, MA-3 & MA-4), or a .051 gage pin (models MA-4-5, MA-4-5AA, MA-5, MA-5AA, MA-6 and MA-6AA) must pass between the lower surface of the upper pontoon and the throttle bore wall and between the lower surface of the lower pontoon and the lower bowl wall without touching either pontoon. Reorient the carburetor so that the other pontoon is uppermost, see Figure 3. Repeat the clearance check. If, as the gage pin is moved along between the float and the bowl wall the gage pin contacts either pontoon, float clearance is inadequate and the float assembly must be replaced.

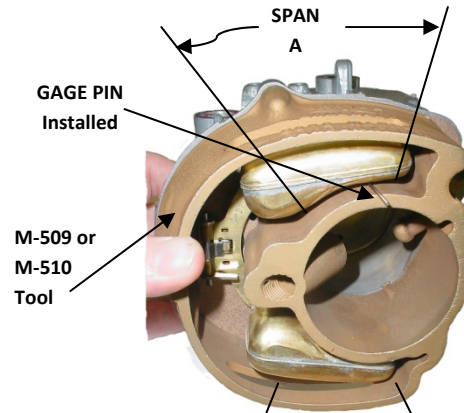
**Fig. 2**

GAGE PINS  
PER CARB  
MODEL  
**.051"**  
MA-4-5/AA  
MA-5/AA  
MA-6/AA  
**.081"**  
MA-2  
MA-3  
MA-4

**Carb Orientation 1, Check Spans A & B**

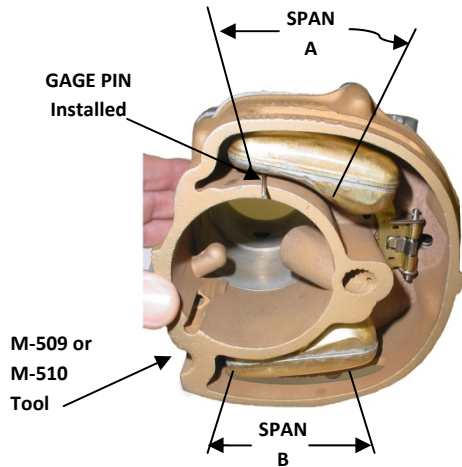
**Fig. 3**

GAGE PINS  
PER CARB  
MODEL  
**.051"**  
MA-4-5/AA  
MA-5/AA  
MA-6/AA  
**.081"**  
MA-2  
MA-3  
MA-4

**Carb Orientation 2, Check Spans A & B**

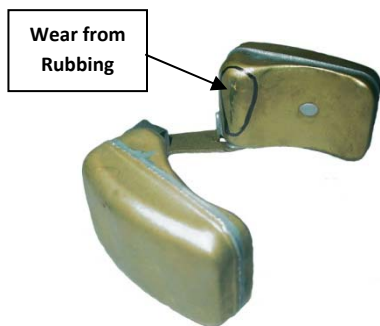
**Fig. 5**

**Example: Wear from Rubbing on Small MA Float**

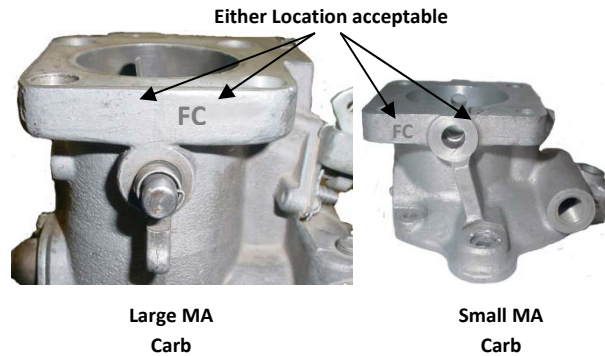
**Fig. 6**

**Conformance with this SB-4 'FC' Stamp Locations**

5. **Identification/Marking:** Upon completion of this Flight Safety Service Bulletin, stamp the letters "FC" ( $\frac{1}{8}$  inch tall (nominal) characters) on the flange adjacent to the throttle shaft, see Figure 6.
