## Volare' Carburetors, LLC

## Service Bulletin: SB-6 Rev A

### SUBJECT – MIXTURE CONTROL STOP WEAR – HA-6 TYPE CARBURETORS.

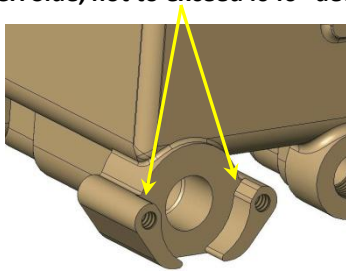
FIGURE 4

- c. Examine the mixture valve stops for wear in the areas shown in Figures 4 & 5. The maximum permissible wear depth is .046 inch.

Check for wear on BODY stops  
EACH Side, not to exceed .046" deep

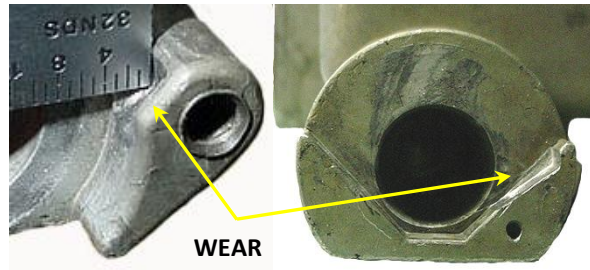
FIGURE 5

Current & earlier fuel mixture stop designs showing excessive wear examples

WEAR

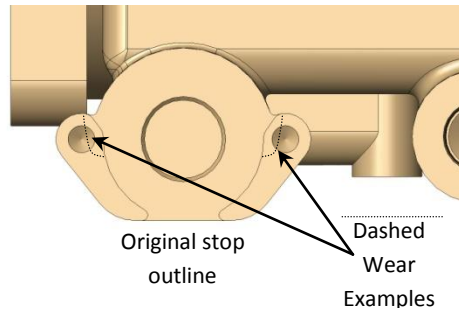
**FIGURE 6**

- e. Use a depth indicator, scale or other suitable measuring device to determine the depth of the wear, if any, of the stops. If the wear exceeds .046 inch below the 'original outline' of the part as shown in Figure 6, the carburetor must be submitted to Volare for repair, as in Figure 7.
