MSA PRODUCT IMPROVEMENT

New Polymer Accelerator Pump Stem Seal

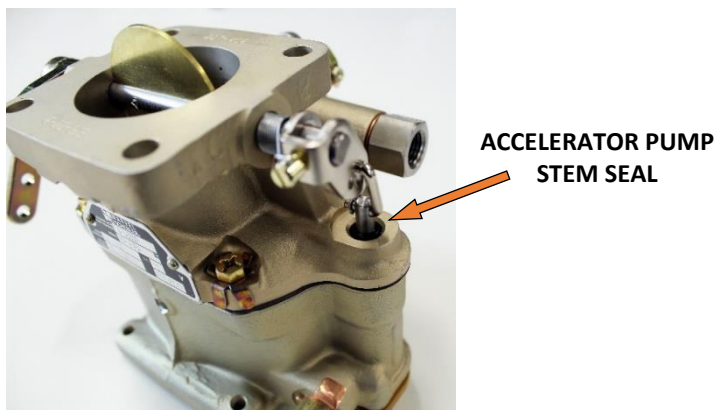
A legacy issue with a small number of these carburetors was engine roughness when minor power changes were made during cruise flight. This happened because of an air leak past the accelerator pump push rod into float bowl.

When the throttle is moved, forces applied to the accelerator pump rod change. If the seal is defective, the movement of the pump rod can cause an air leak between the seal and the rod.

Legacy carburetors used leather seals. Those seals could dry up, shrink, rot, split, or take on permanent deformation, causing them to leak excessively and, once deformed, the leather had very little ability to return to its original shape and make a good seal against the rod again.

Modern polymers do not suffer from the same problems as leather – at least not to the same extent. The material MSA used for its improved polymer seal is essentially immune to wear or deterioration in this application. Nearly three quarters of a million cycles were accumulated on the rod / seal combination during development of the new seal. No discernable wear or deterioration of the seal or rod was noted during these tests.

MSA pursues a relentless passion for continuous product improvement. Thus, we developed the new polymer seal to help eliminate the engine roughness problem described. The new seal achieved that goal. Since its introduction, reports of intermittent engine roughness concurrent with throttle changes have dropped to essentially zero.
