## Marvel-Schebler<sup>®</sup> Aircraft Carburetors, LLC

## **Service Bulletin: SB-15**

## SUBJECT – THROTTLE PLATE SCREW SECURITY

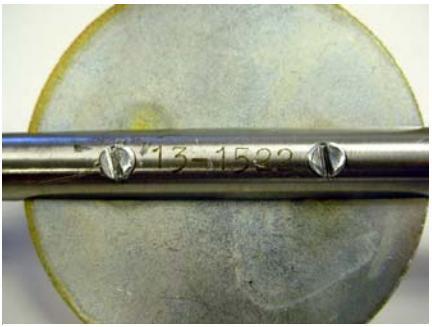
Figure 2 Preferred Method for MA-3™ Series Carburetors Correct Tool: VM-109

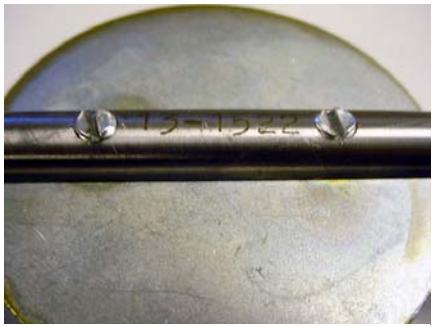
Figure 3 Preferred Method for MA-3™ Series Carburetors Correct Tool: VM-109

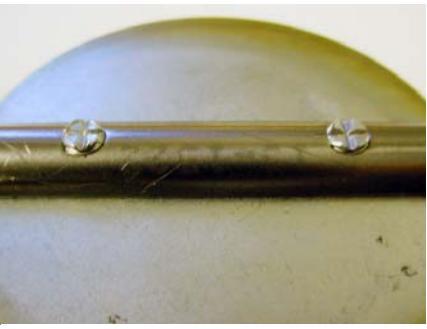
Figure 4 Preferred Method for MA-4™, MA-4-5™, and HA-6™ Series Carburetors Correct Tool: VM-107

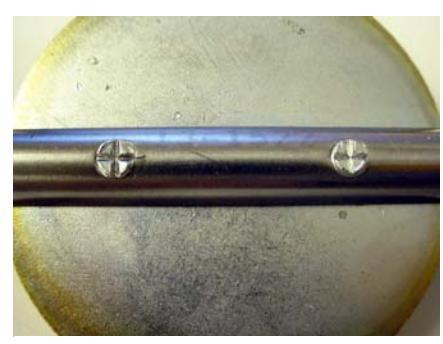
Figure 5 Preferred Method for MA-4<sup>™</sup>, MA-4-5<sup>™</sup>, and HA-6<sup>™</sup> Series Carburetors Correct Tool: VM-107

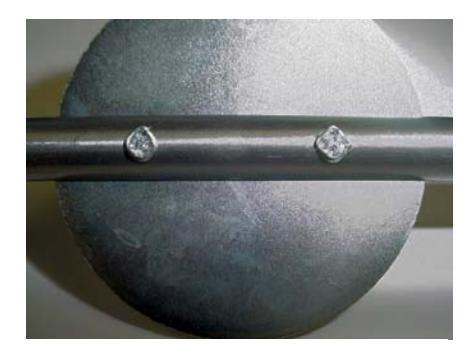
**Figure 6** <u>Correct</u> Alternate Method Only Screws Upset (No Shaft Damage) Tool: Standard Center Punch

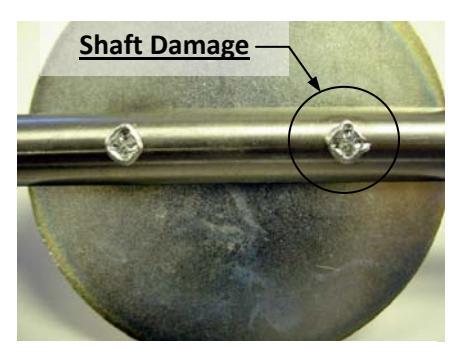
Figure 1 shows a throttle shaft and throttle valve retention screws. Staking marks can be seen in the shaft. The screws are not staked. The customer reported that the carburetor was received as part of a factory overhauled engine. It is not known if carburetors with non-staked throttle valve screws are reaching the market through other means of distribution. Figures 2 thru Figure 6 show correctly staked throttle valve retention screws. Note that the throttle shaft is not staked. The ends of the SCREWS must be upset sufficiently to prevent the screws from backing out through the shaft threads even if the screws lose torque in the shaft threads. Figure 7 shows an incorrectly staked assembly – The shaft is damaged.

**Figure 7** <u>Incorrect</u> Method Shaft Damaged Tool: Standard Center Punch
