## Marvel-Schebler<sup>®</sup> Aircraft Carburetors, LLC

## **Service Bulletin: SB-15**

## SUBJECT – THROTTLE PLATE SCREW SECURITY

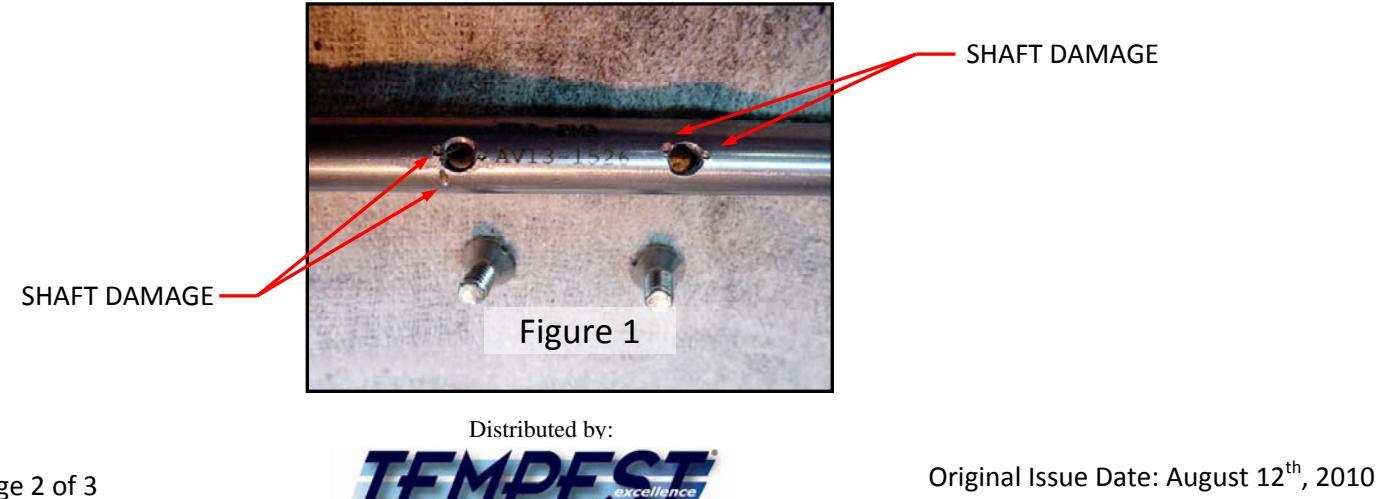
Figure 1 shows a throttle shaft and throttle valve retention screws. Staking marks can be seen in the shaft. The screws are not staked. The customer reported that the carburetor was received as part of a factory overhauled engine. It is not known if carburetors with non-staked throttle valve screws are reaching the market through other means of distribution. Figures 2 thru Figure 6 show correctly staked throttle valve retention screws. Note that the throttle shaft is not staked. The ends of the SCREWS must be upset sufficiently to prevent the screws from backing out through the shaft threads even if the screws lose torque in the shaft threads. Figure 7 shows an incorrectly staked assembly – The shaft is damaged.

Visually inspect the throttle shaft and the ends of the screws to ascertain that the screws a. are staked in accordance with this service bulletin and that the throttle shaft has not been staked.

b. If a staked throttle shaft or one or more non-staked throttle valve retention screws are identified, remove the carburetor from service and replace it with a serviceable carburetor.
